Beluga™ Bags Daytona Beach, Florida

CASE STUDY: Beluga™ Bags | Daytona Beach, Florida

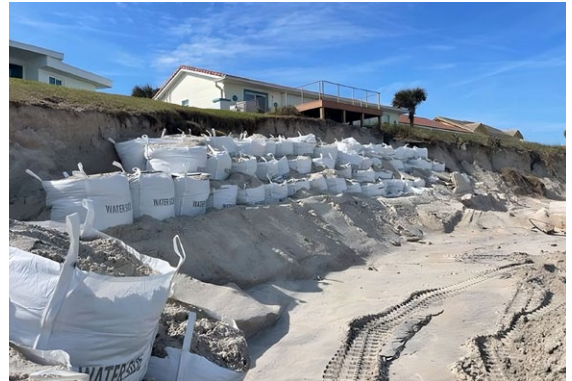
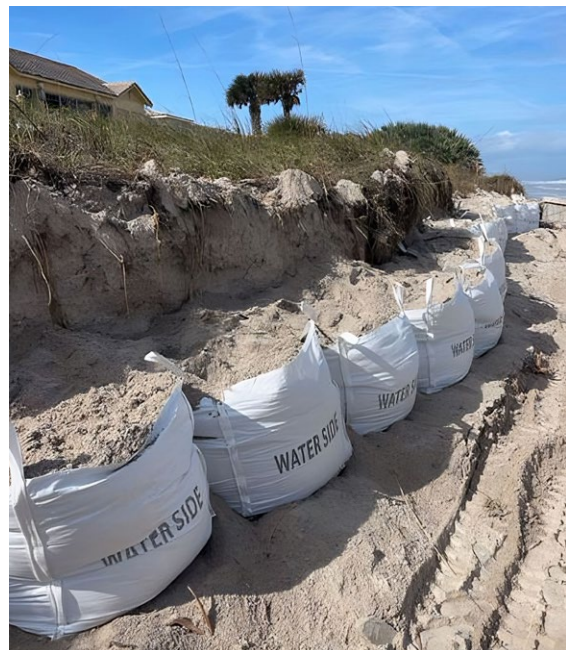
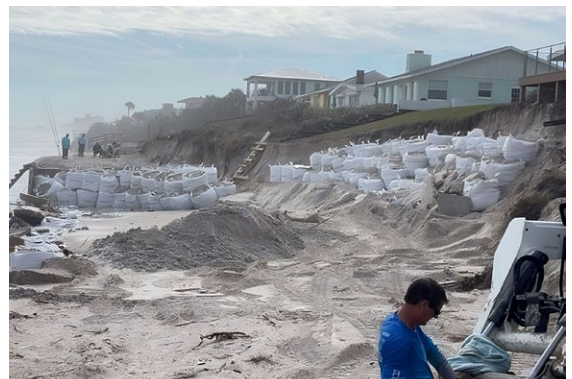
In order to protect homes along the shorefront, while restoration and reconstruction of the area occurred, 425 Beluga™ Bags were deployed spanning the length of 5 high value beachfront homes, resulting in over 1000ft of protection. In some areas, the Beluga™ Bags were stacked 4-5 layers high to create the most optimal height of protection against incoming King tides. While reconstruction is still underway in the Daytona Beach area, the Beluga™ Bags remain in place ready to protect shorefront properties. It is likely that bags will remain in place even as the shorefront is rebuilt and extended back to its original location, providing continual internal support.

- Single Beluga™ Bags (BG1) are 3ft Long, 3ft Wide and 40in High
- 5-Compartment Beluga™ Bags (BG5) are 15ft Long, 3ft Wide and 40in High
- Zero wasted space allows for half the amount of sand required for sandbags
- Deployment is made easy with a relatively small crew
- Stackability helps to create significant protection against rising flood threats
