### Hammerhead™ Amalgamated Warbasse Houses

## HAMMERHEAD ALUMINUM FLOOD PLANKS

## CASE STUDY: Hammerhead™ | Amalgamated Warbasse Houses

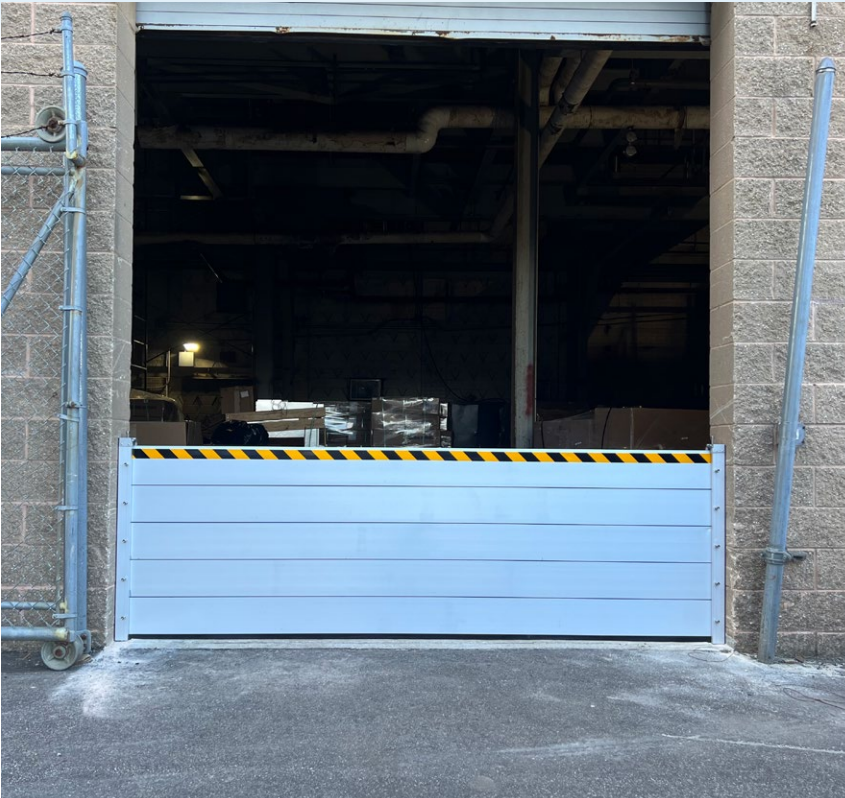
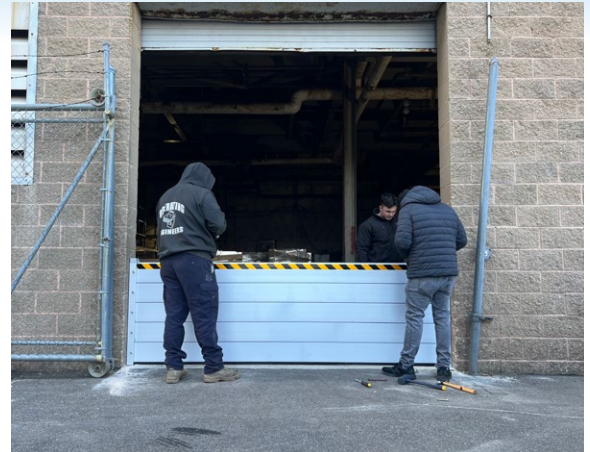
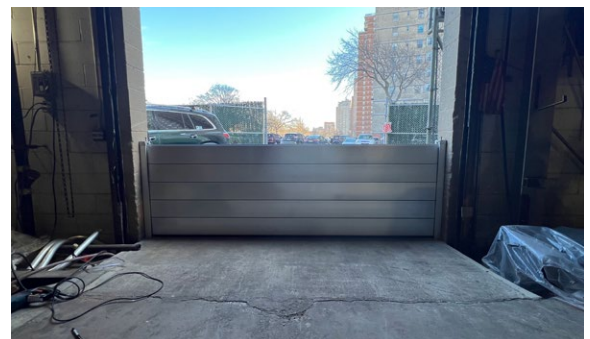
The Hammerhead™ Aluminum Flood Plank system is designed to protect a variety of entryways from the dangers of flooding. U-Channel posts are installed on both sides of an entryway allowing for individual aluminum planks to be slotted into the posts and tightened down to provide durable flood protection. The system allows for the flexibility of keeping entryways accessible and also providing easy and rapid deployment for when a flood threat arises. The Hammerhead™ System can protect against flooding up to 6.5 feet high (higher with engineering review). The system allows for plank widths up to 12 feet wide.

- The Hammerhead™ Aluminum Flood Plank System easily installs into entryways using U-Channel Posts and aluminum flood planks (flood logs) that are inserted into the posts when needed.

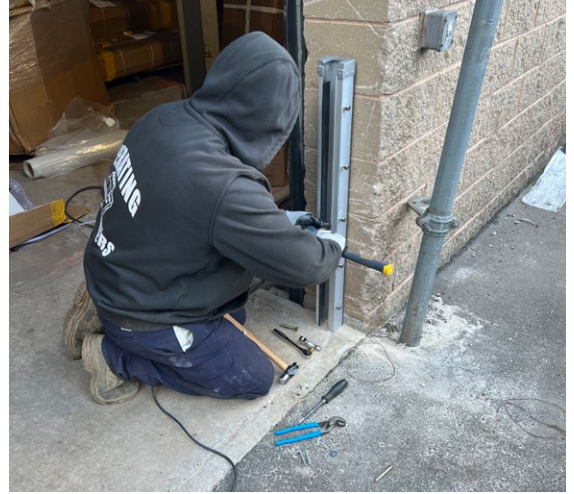
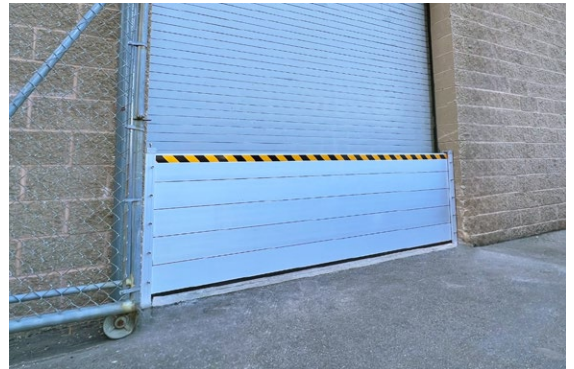
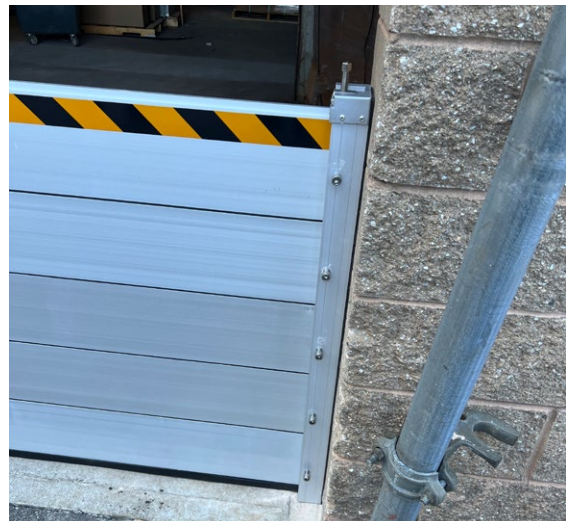
We concluded that the Hammerhead™ Aluminum Flood Planks were the most effective solution to provide for Warbasse. We deployed Hammerhead™ at every entrance and bay door of their independent power plant. Additionally Hammerheads were used for the appropriate entryways for the equipment and pump rooms. The durability of Hammerhead™ ensures that the most effective measures are in place to combat future flood threats to the Warbasse property.
