Hammerhead™: Aversana at Hammock Bay Condominiums, Naples Florida

HAMMERHEAD ALUMINUM FLOOD PLANKS

CASE STUDY: Hammerhead™ | Aversana at Hammock Bay Condominiums

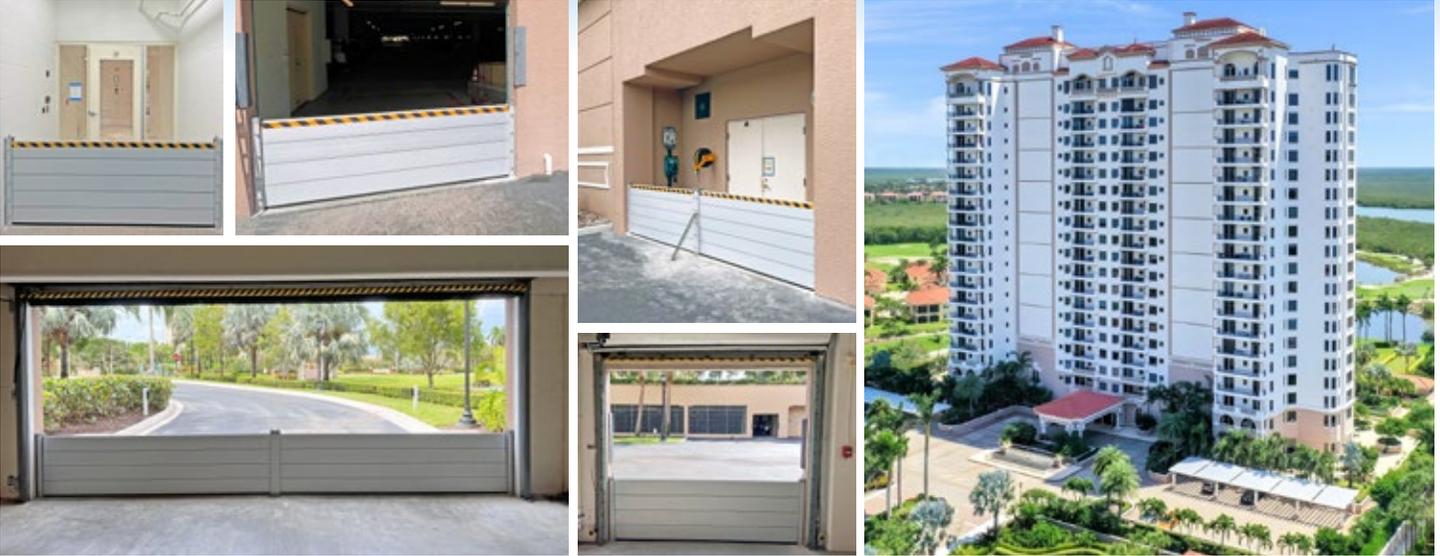
One of the key advantages of the Hammerhead™ flood log system is its rapid deployment capability. The system is designed to be easily deployed by a single person, making it highly efficient for emergency situations. Flood planks are inserted into U-shaped channels and securely tightened against rubber seals, creating a robust and leak-resistant barrier. Additionally, when not in use, the Hammerhead™ system can be compactly stored, minimizing space requirements and allowing for convenient access when needed.

Garrison Systems' installation team completed the installation of the Hammerhead™ flood log system at Aversana in just two days. In-wall anchors were installed to allow for the easy removal of the barrier posts when they were not in use. This installation method ensured that the flood protection system seamlessly integrated with the condominium's infrastructure without disrupting its aesthetics.
