Hammerhead™ Aluminum Flood-Log System: Village of Island Park Firehouse

CASE STUDY: Hammerhead™ | Village of Island Park Firehouse

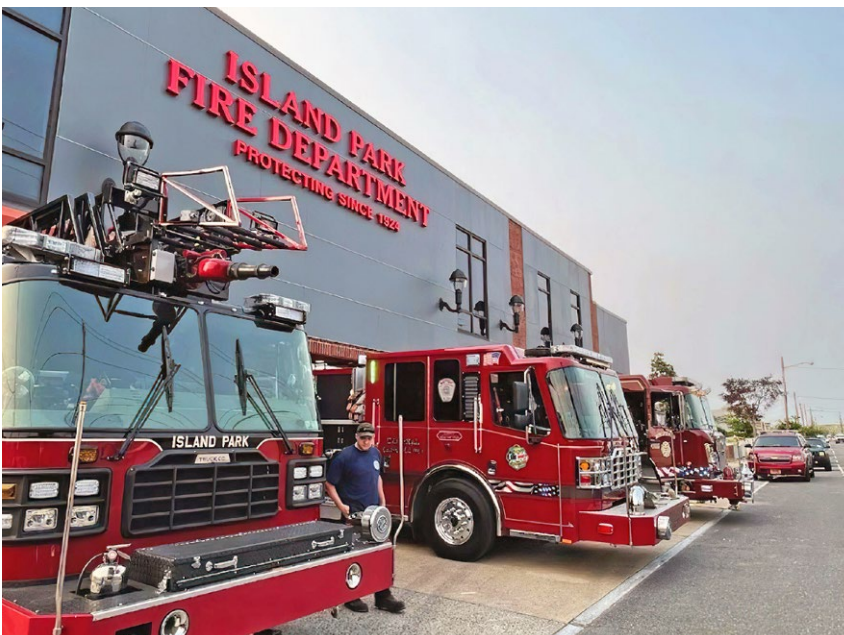
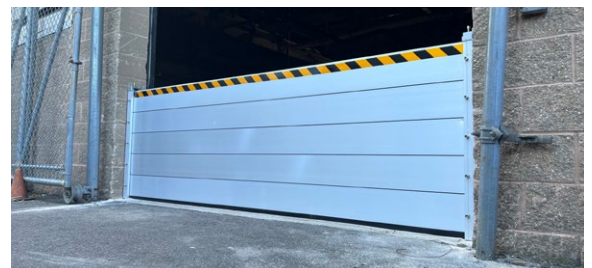
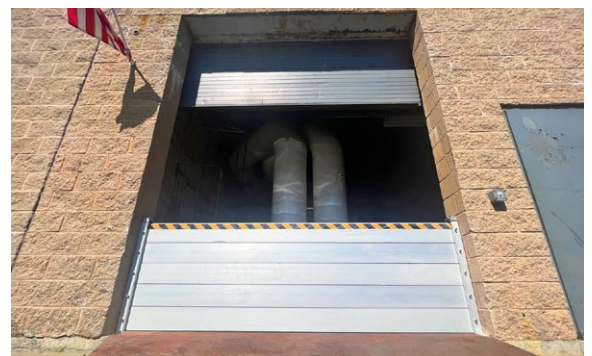
The Hammerhead™ system utilizes sturdy, aluminum planks that are easily slotted into pre-installed U-Channel posts and tightened down against neoprene seals, quickly forming a reliable flood barrier. Planks contain internal ribbing for additional strength and are manufactured using a durable 6063-T5 aluminum. Posts incorporate neoprene seals, tightening bolts and caps that apply downward pressure to the system, enhancing the seal between planks.

Hammerhead™'s design, using a series of roughly 8" tall planks, is easy to transport as planks weigh only 2lbs per linear foot and can be moved by one person. Aluminum planks are conveniently stacked and stowed away when not deployed, meeting the need for an efficient use of space in the firehouse.

- Hammerhead™ Aluminum Flood Planks easily slot into installed U-Channel posts to create a durable flood wall.
- Hammerhead™ was deployed at the firehouse's main entrance, back patio doorway, various windows and the four fire truck bay doors.

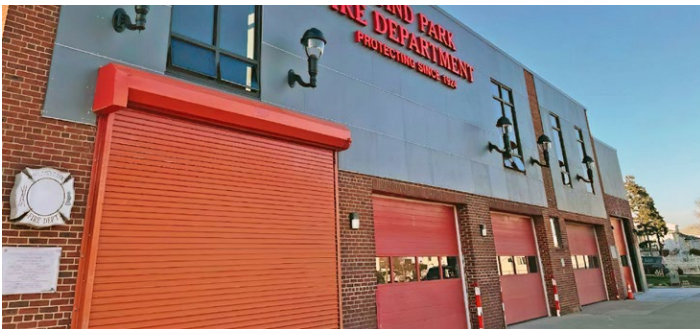
Furthermore, the Hammerhead™ system delivers robust flood protection up to the required height of 6.5 feet. Hammerhead™ was deployed at the main entrance, various windows, the back patio door, and, most importantly, the four oversized fire truck bay doors. To bolster the support against hydrostatic pressures for these larger doors, removable center posts with concrete anchor plates, and additional kicker supports were added. This ensures that the flood barrier system can handle the hydrostatic pressures expected during a typical flood.

To address these challenges, Garrison Flood Control provided the Hammerhead™ Aluminum Flood Plank system to shield the firehouse's main entrance, various windows, the back patio door, and four fire truck bay doors against floodwaters. For the larger doors, additional support against hydrostatic pressures was incorporated through removable center posts with anchor plates inserted into the concrete and additional kicker supports added.

- Removable center posts with concrete anchor plates were installed to withstand the expected hydrostatic pressure documentation.
- [View Hammerhead Testing](#)
